**Docket No. 217 – Development and Management Plan Inspection**

Northeast Utilities Service Company Certificate of Environmental Compatibility and Public Need for the construction of a 345-kV electric transmission line and reconstruction of an existing 115-kV electric transmission line between Connecticut Light and Power Company's Plumtree Substation in Bethel, through the towns of Redding, Weston, and Wilton, and to the Norwalk Substation in Norwalk, Connecticut.

**Date:** December 14, 2005

**Location:** Transition Stations: Hoyts Hill, Archers Lane, Norwalk Junction

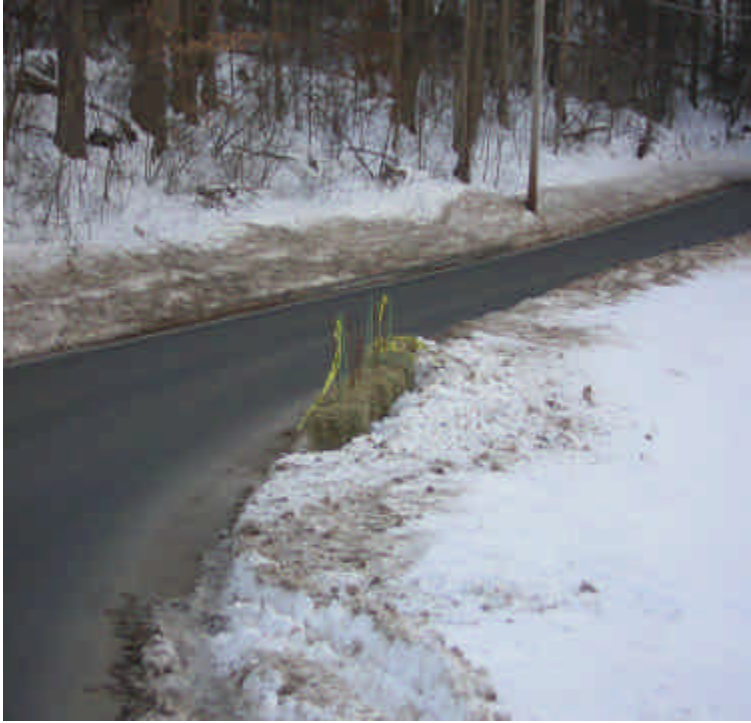
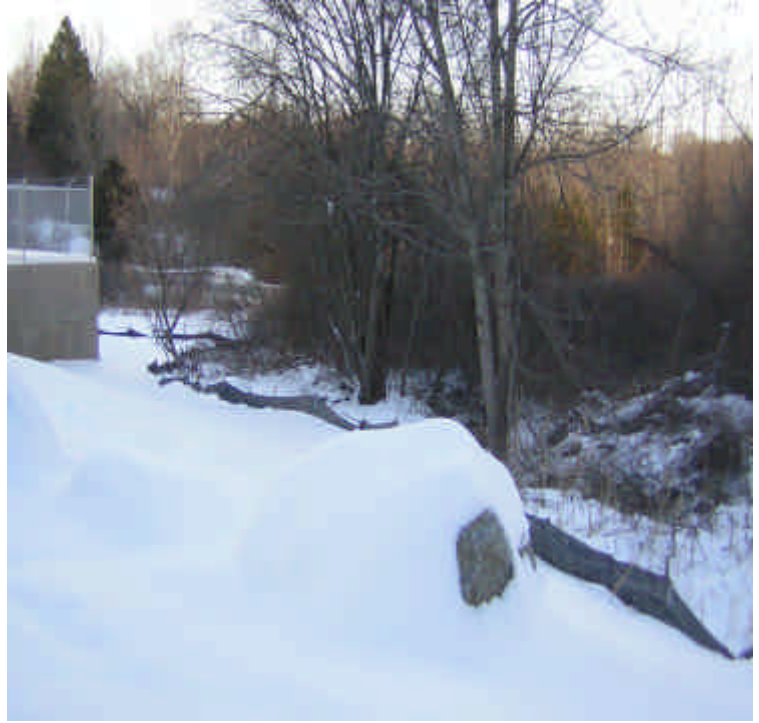
**Hoyts Hill Transition Station: Photo on the left shows where haybales were installed along the site access point prior to snow cover. Photo on the right is a view along the southern perimeter fence. 12/14/05**

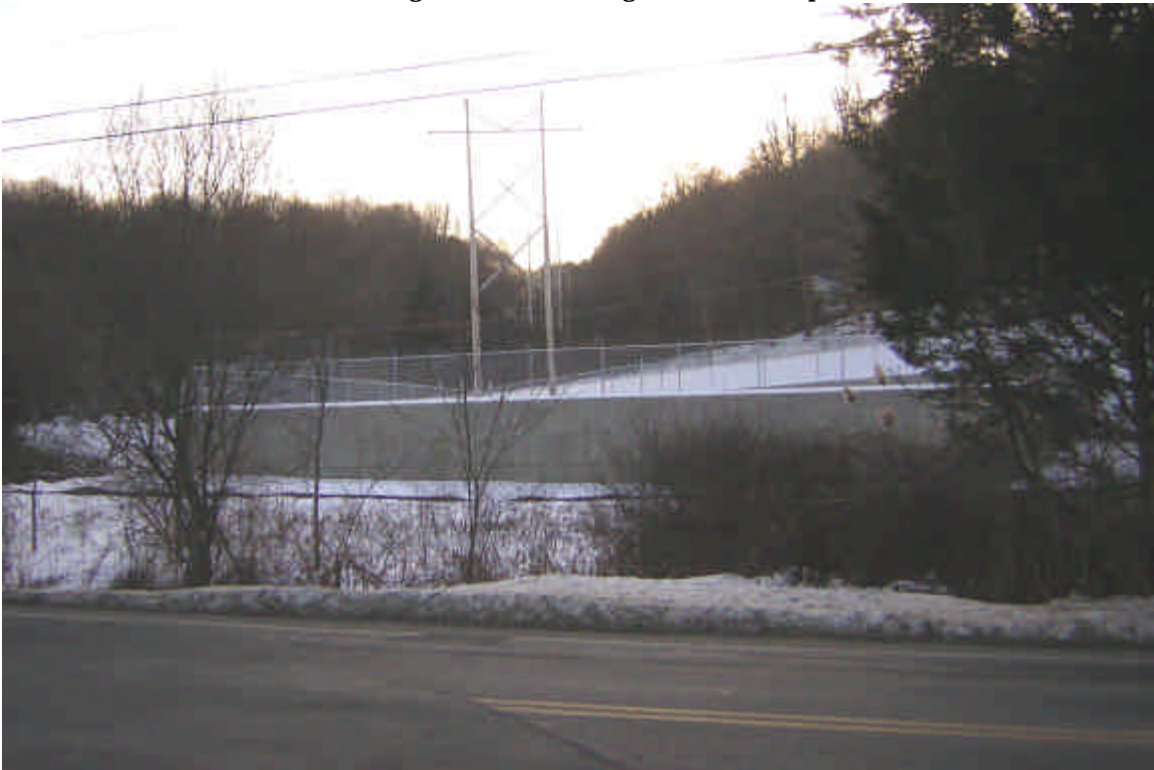
**Overview of the transition station wall and pad from Rt. 58. 12/14/05.**

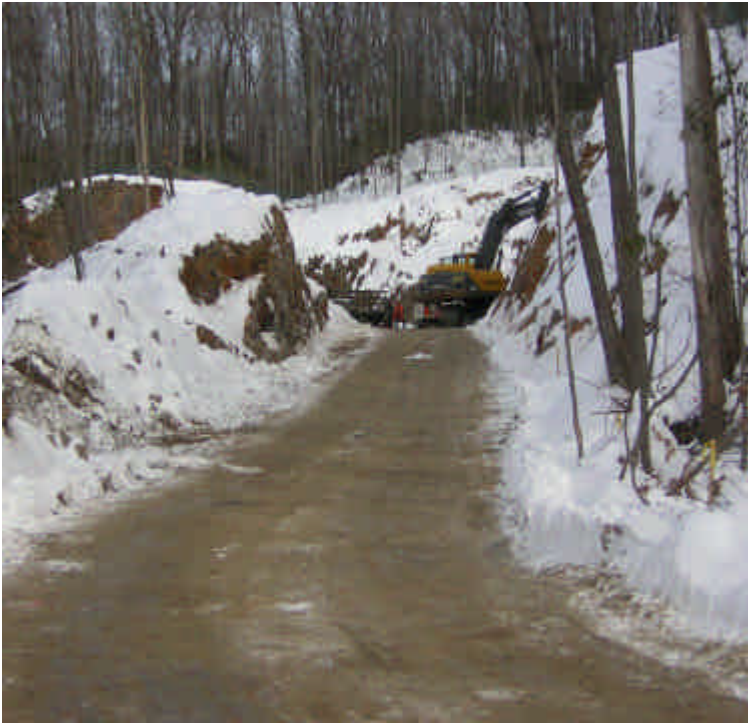
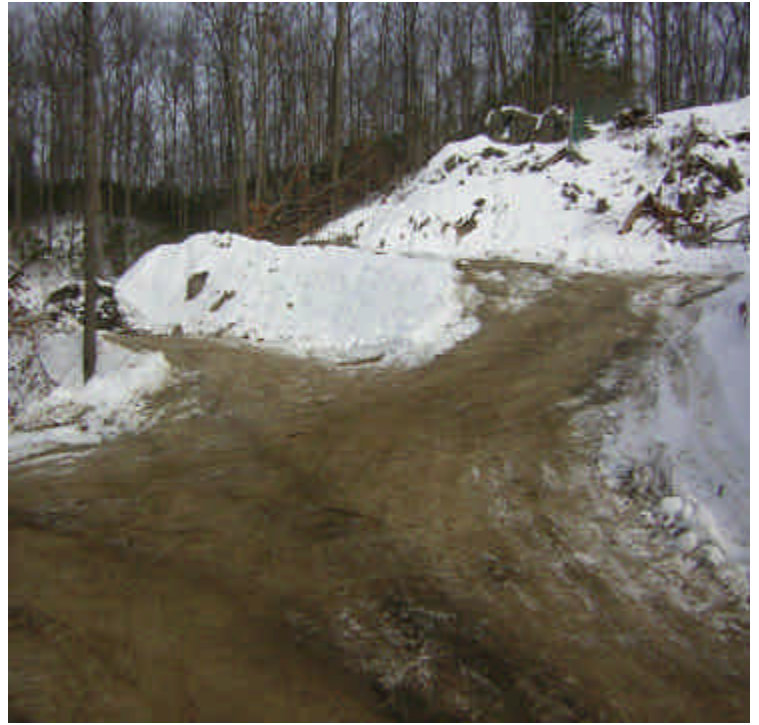
**Archers Lane: Photo on the left shows a view of the completed upgradient access road into the site. Photo on the right shows additional view into the station site. 12/14/05.**

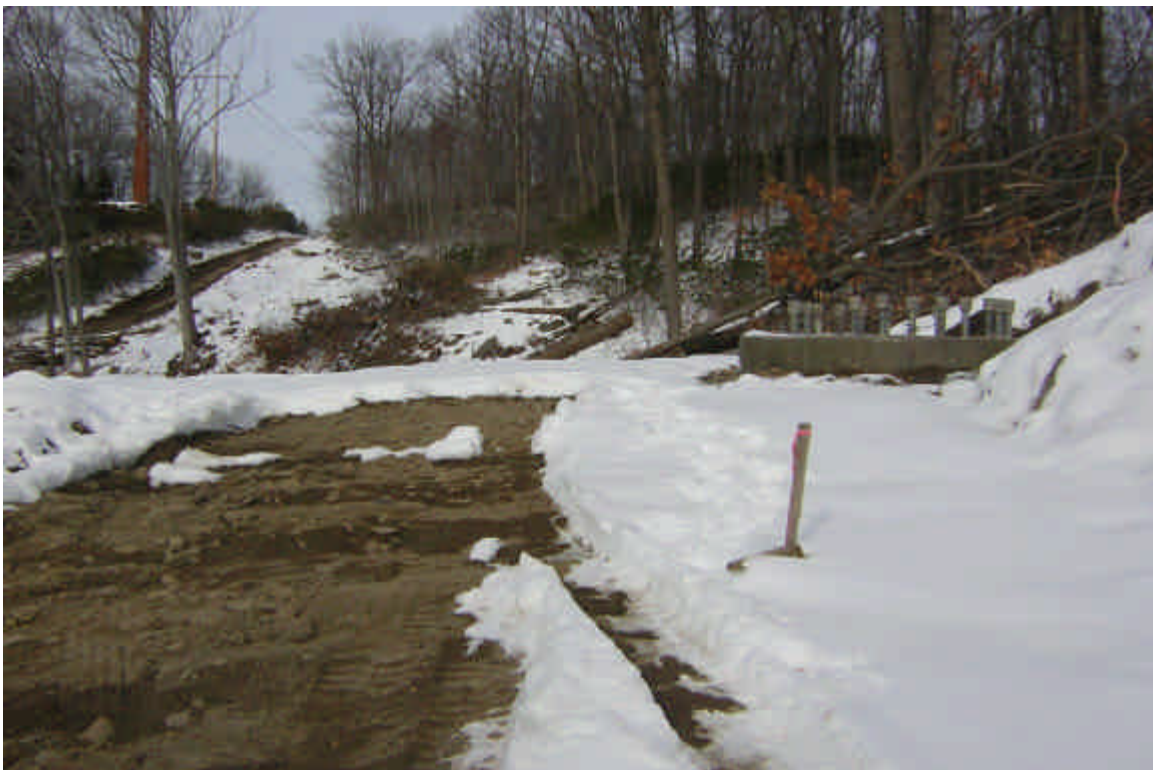
**View of the recently installed structure foundation located adjacent to the transition station and where access was cleared to the ROW. 12/14/05.**

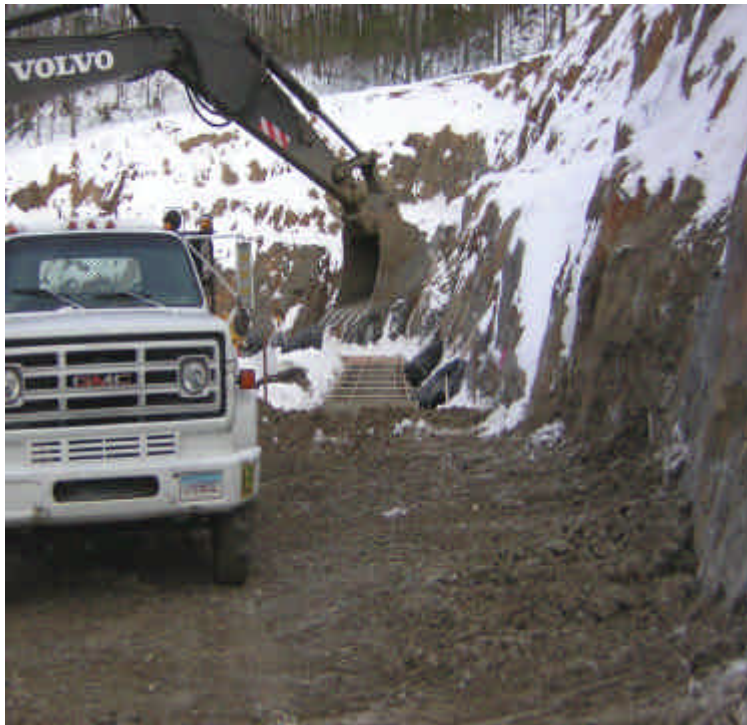
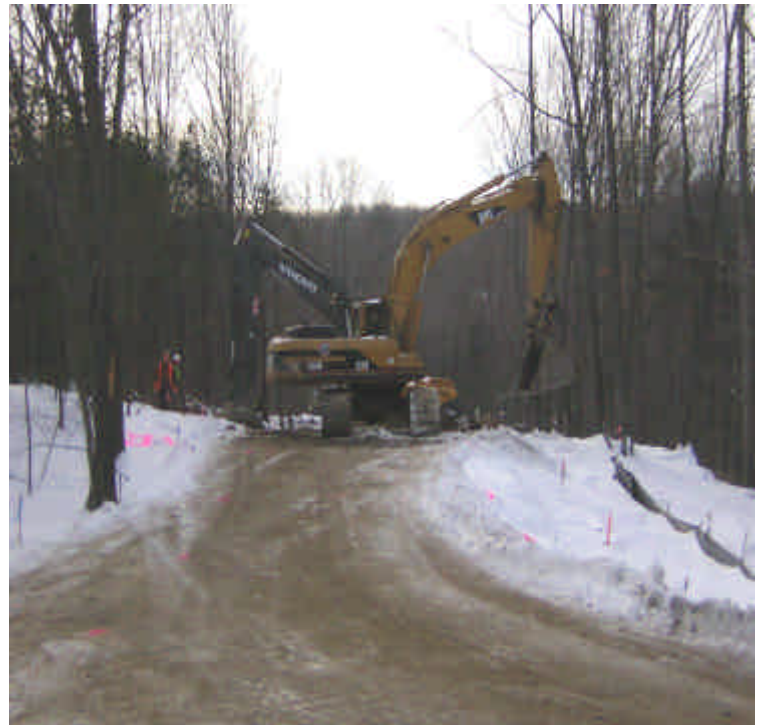
Photo on the left shows where construction has begun on retaining wall footings. Photo on the right shows where excavators are working on a vault location for installing the connecting 345kV infrastructure. 12/14/05

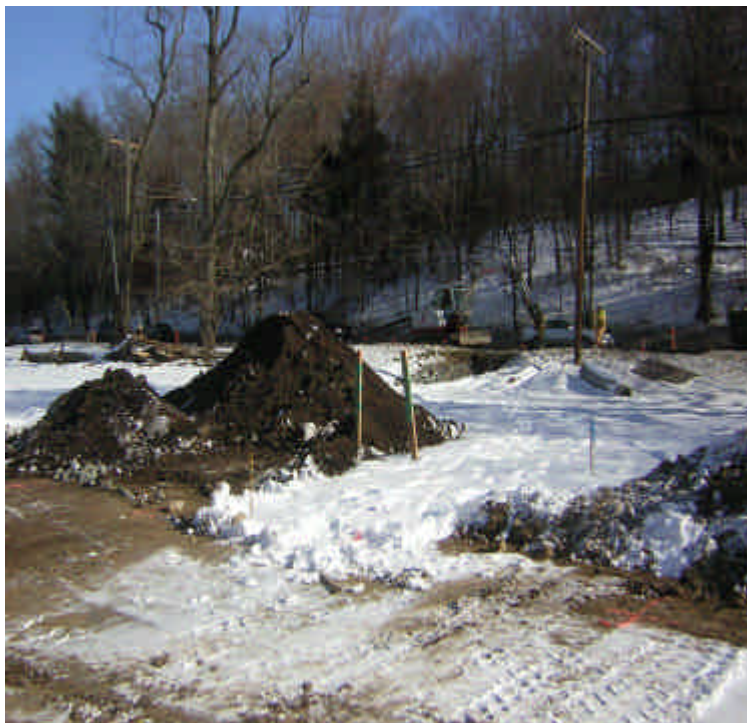
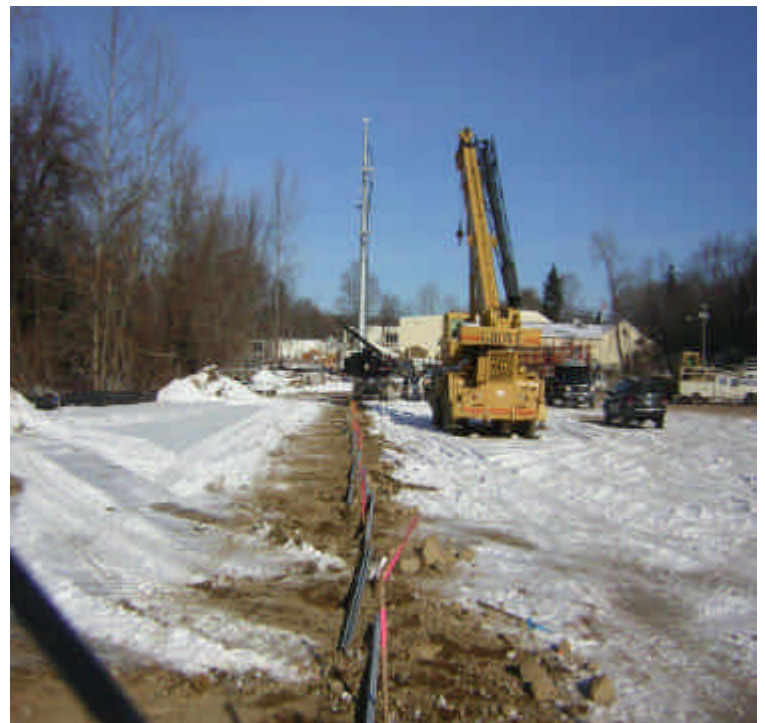
Norwalk Junction: Overall view of the site towards some of the work. Photo on the left shows a view towards Rt. 7 of the stone work at an outlet and stockpiles. Photo on the right shows a view of the staking for the site layout. 12/14/05

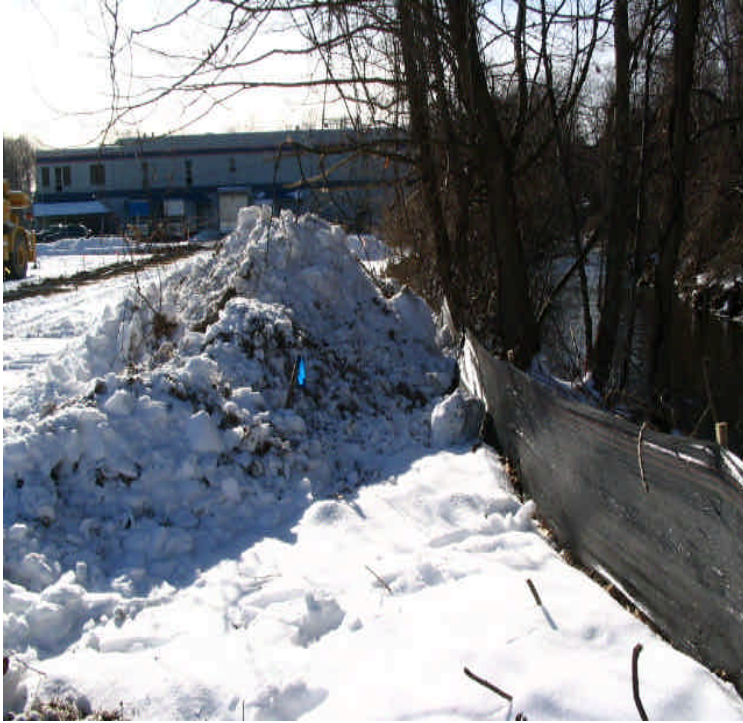
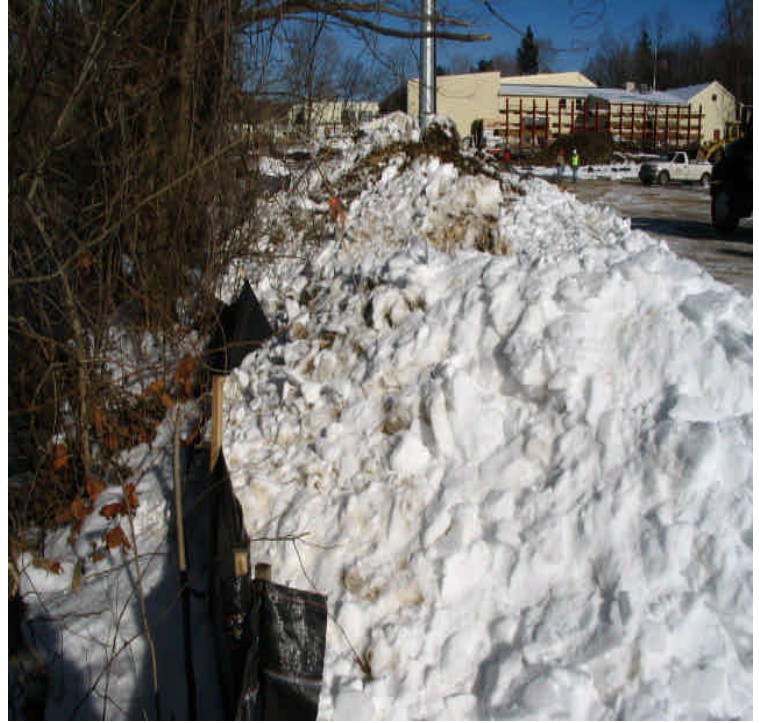
Both photos are views of the snow that was plowed up to and over the existing perimeter silt fence. This was apparently a result of 115kV and not transition station work and should be pulled back from the fence. Plowed snow picks up sediment which is now past the perimeter barriers. 12/14/05

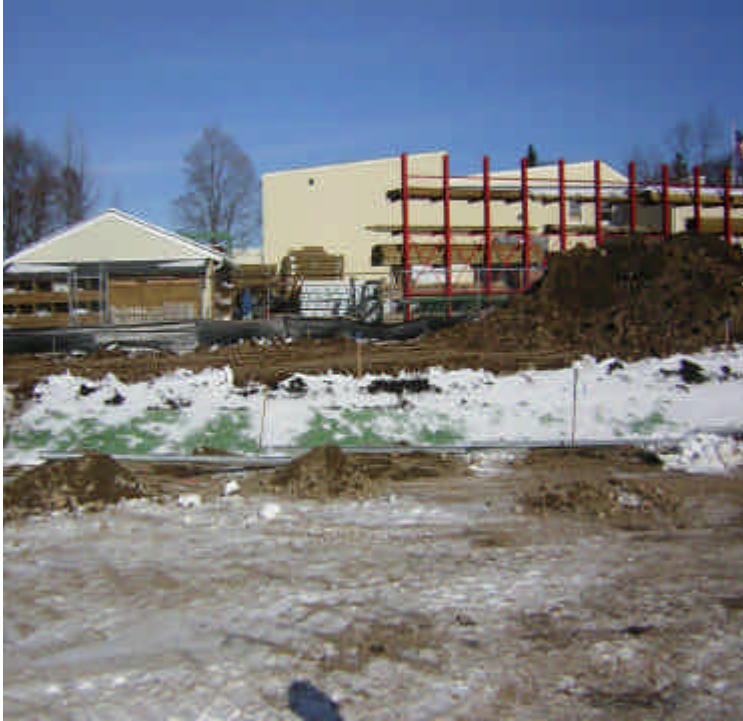
Photo on the left shows the completed drainage swale along the access road. Erosion control matting was installed on the slope here. A haybale should be placed at the inlet or outlet for now until the surrounding area is stabilized. 12/14/05

Areas of Inspection	Observation	Recommended Action
Erosion and Sediment Controls continued	<p>-The gullies appear to begin at the outlet pads. It may be necessary to extend the pads since they are not reducing velocity appropriately. 11/02-12/14/05.</p> <p>- <b>Archers Lane:</b> Monitor stormwater run-off velocity off the engineered slope. This area is steep and water used to collect at the base at the silt fence. 12/14/05.</p>	<p>-Investigate whether extension of the stone pad would help the situation and restore the erosion caused here. 12/14/05. Haybales were installed at the top of slope, not at the outlet as we expected. 12/14/05</p> <p>- Continue to monitor this area, especially after significant rain events. This is where sediment had previously collected. 12/14/05.</p>
	<p>- <b>Norwalk Junction:</b> Some snow was plowed up and over the perimeter silt fence adjacent to the Norwalk River apparently due to the 115kV portion of the work. Plowed snow picks up sediment which is now past the perimeter barriers. The controls are in need of repair in a number of spots. 12/14/05.</p> <p>-The cleared/disturbed soils noted outside the silt fence adjacent to the wetland are still present under snow cover.12/8-12/14/05</p> <p>- Small stockpiles of stone and soil were noted but remain internal to the site. 12/14/05.</p> <p>- Although the drain swale is complete and in good shape, surrounding soil is disturbed. 12/14/05</p>	<p>-Repair and maintain erosion controls and pull back snow piles. Refrain from placing sediment laden snow up to and over erosion controls. This will likely be the responsibility of the 115kV contractor. 12/14/05</p> <p>- This newly disturbed area adjacent to the river should be mulched or erosion controls should be extended to encompass. 12/1-12/14/05.</p> <p>- Watch for any soil migration towards the drainage swale. 12/14/05.</p> <p>-Place a haybale either at the inlet or outlet until the surrounding area is stabilized. 12/14/05.</p>
